Wings of warm

Loose values

Recall Roster

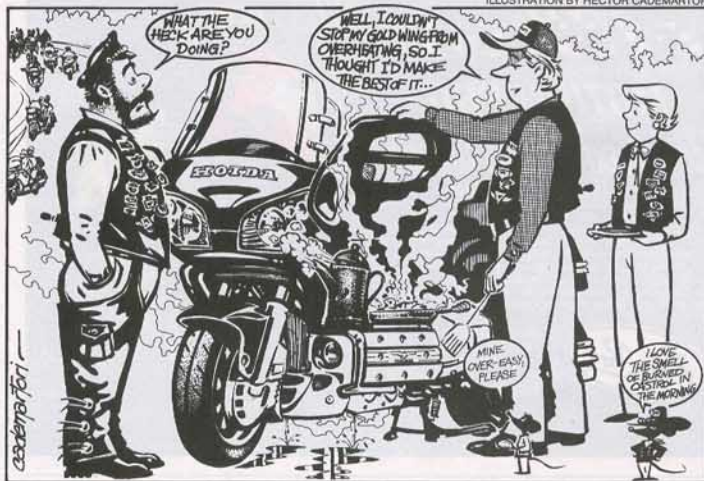
Save the postage, Niles. This past December, American Honda sent a letter to all the original owners of GL1800s acknowledging the company's awareness of an overheating problem. According to the letter, approximately 1 percent of the 25,000 GL1800 owners in the U.S. have reported instances of the needle on the coolant temperature gauge moving up into the red zone, but only when the ambient temperature is high, and only when the bike is ridden very slowly, usually around 10 mph. When I spoke with a Honda representative about the problem, he referred to this style of riding as "parade mode." He said that almost all of the reported incidents had occurred while the bike was either crawling through

traffic at a walking pace or taking part in an actual parade.

In the letter, Honda pledges to find a solution in time for the upcoming summer riding season. Until then, GL owners who are riding slowly and observe the temperature beginning to rise are advised either to increase their speed or shift into second gear. If that simply is not an option and the coolant-temperature needle reaches the red zone, the rider should pull over to the side of the road as soon
